U.S. NAVAL ACADEMY, ANNAPOLIS, MARYLAND

EPDM AND POLY URETHANE FOAM RESURFACING

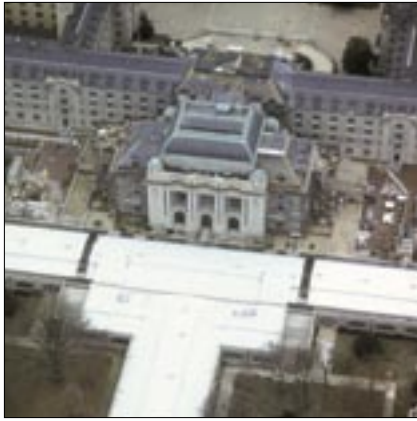
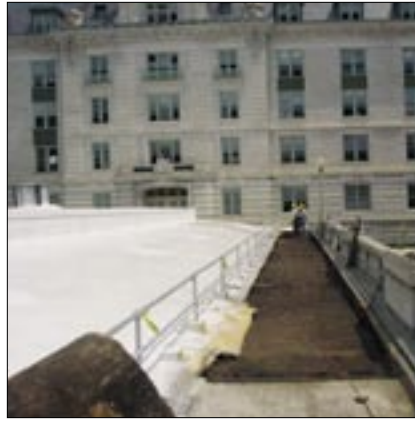
Issues Identified: The roof consisted of large barrel roofs with hundreds of feet of valleys that were covered by heavy, corrugated-steel grating, which served as walkways. The failed condition of the existing roof was extreme.

The aged EPDM rubber roof seams were open, allowing water to enter through the original built-up roof.

First on the agenda was to power wash the entire existing EPDM surface, followed by cleaning and priming with a specially formulated EPDM primer. Then the crew from Lake Industrial applied a fabric mesh tape to all the seams and recoated the seams with Truco’s solvent-based coating. The mesh tape allows the coating to permeate the fabric, acting as a coating adhesive to the EPDM surface. According to Markferding, this method is becoming a standard application technique in the coating of EPDM rubber roofs.

Product Identified: The next step was the coating process. The crew first applied the base coat to begin to build the specified thickness and to help stop some of the numerous leaks in the building. After the base coat was installed on the upper portions of the barrel roofs, the Lake Industrial team installed SPF in those valleys that did not have corrugated steel grating. The SPF was sloped to the drains to help eliminate water ponding in the valleys and transitional roof areas, which were flat and funneling water from one roofing plane to another. “This was a successful approach,” Markferding explains, “especially since using SPF on the entire roof was too costly for the Academy’s budget.”

be saved. In these areas, tear-off was required. After removing the two types of roofing, Lake Industrial mechanically installed a layer of isocyanurate insulation board to serve as the receiving surface for the SPF roofing. After the SPF was installed, a base coat was applied to protect the SPF from ultraviolet degradation while the crew rebuilt the saturated valleys.

The next step was to apply the industrial polyurea coating onto all the steel supports that carried the corrugated steel grating. The polyurea coating was also installed over old copper flashing that had sprung open and was not performing as intended. When all of the valleys were finished, Lake Industrial applied two more coats of the solvent-based white coating and reinstalled the hundreds of feet of corrugated steel grating. The final detail was to apply urethane caulking and the open mesh fabric around all of the perimeters of the roofing surface.
